# Laboratory Acoustical Test Report

# FC23-0886

Impact Insulation Class, Delta Impact Insulation Class, and Sound Transmission Class

**Test Assembly:** Urban Surfaces 7501 Canal Street Urban Surfaces FloorSilencer Pro 152 mm Concrete Slab

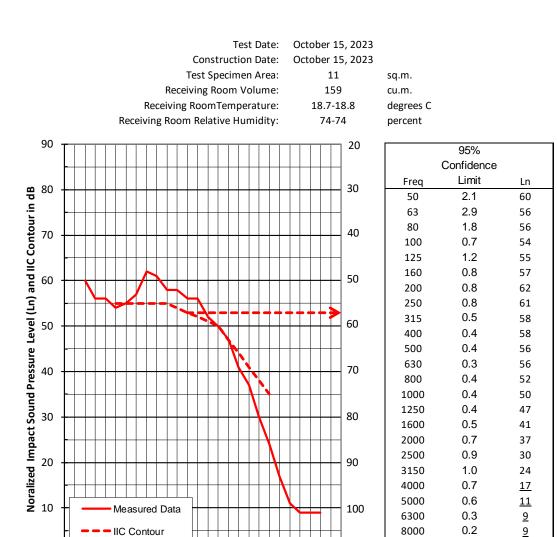
#### Impact Insulation Class Test FC23-0886: IIC 57

3 mm Urban Surfaces 7501 Pearl (Adhered to Sound Mat) 1.3 mm Urban Surfaces FloorSilencer Pro (Adhered to Assembly) 152 mm 5000 PSI Concrete Slab No ceiling

0.1 Background Affected

All tests were conducted in accordance with ASTM E492, "Standard Test Method for Laboratory Measurement of Impact Sound Transmission through Floor-Ceiling Assemblies Using the Tapping Machine." The IIC is a single-number rating derived from the Impact Sound Pressure Level in accordance with ASTM E989, "Standard Classification for Determination of Impact Insulation Class (IIC)." Results are presented above.

95% confidence intervals represent uncertainty for microphone averaging, not tapping positions.

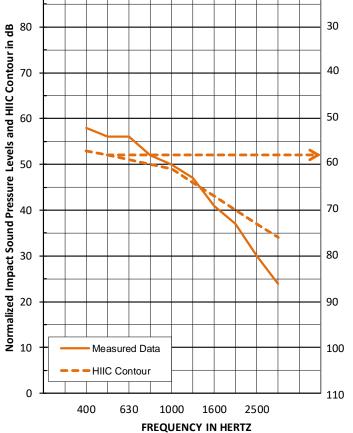
#### High-frequency Impact Insulation Class Test FC23-0886: HIIC 58

3 mm Urban Surfaces 7501 Pearl (Adhered to Sound Mat) 1.3 mm Urban Surfaces FloorSilencer Pro (Adhered to Assembly) 152 mm 5000 PSI Concrete Slab No ceiling

95%						
	Confidence						
Freq	Limit	Ln					
400	0.4	58					
500	0.4	56					
630	0.3	56					
800	0.4	52					
1000	0.4	50					
1250	0.4	47					
1600	0.5	41					
2000	0.7	37					
2500	0.9	30					
3150	1.0	24

) 1.0 No Ln values were affected by background

noise or flanking.

The HIIC is the High-frequency Impact Insulation Class and is meant to assess the high-frequency impact noise on a floor-ceiling assembly. The higher the value, the better the floor, meaning less noise from high-frequency impacts in the space below.

All tests were conducted in accordance with the requirements of ASTM E492, "Standard Test Method for Laboratory Measurement of Impact Sound Transmission through Floor-Ceiling Assemblies Using the Tapping Machine," using ASTM E3222 "Standard Classification for Determination of High-frequency Impact Sound Ratings" to calculate the High-frequency Impact Insulation Class (HIIC). Results are presented above.

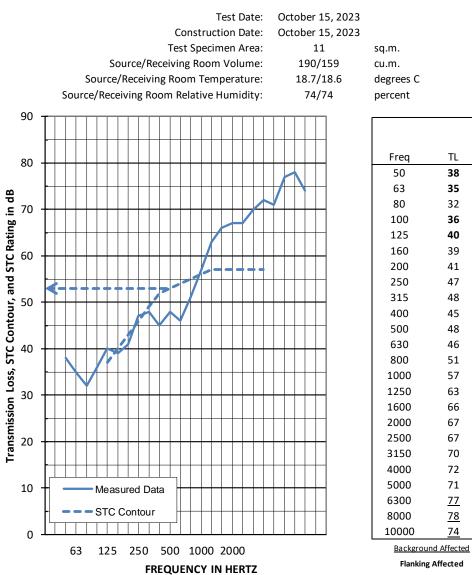
#### Sound Transmission Class Test FC23-0886: STC 53

3 mm Urban Surfaces 7501 Pearl (Adhered to Sound Mat) 1.3 mm Urban Surfaces FloorSilencer Pro (Adhered to Assembly) 152 mm 5000 PSI Concrete Slab No ceiling

Background and Flanking Affected

All tests were conducted in accordance with ASTM E90, "Standard Test Method for Laboratory Measurement of Airborne Sound Transmission Loss of Building Partitions," using the single-direction method. STC is a single-number rating derived from measured values of Sound Transmission Loss through a test specimen in accordance with ASTM E413, "Classification for Rating Sound Insulation." Results are presented above.

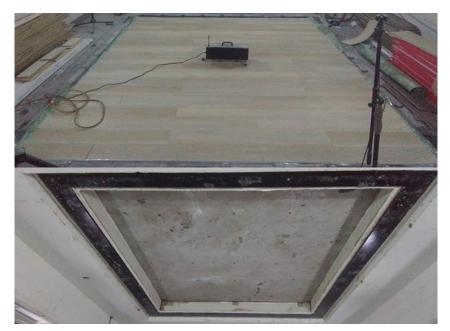
Photo 1: View of Source Chamber, finish flooring installation observed

Photo 2: View of Receive Chamber, bottom of concrete slab observed
