Laboratory Acoustical Test Report

FC23-0755

Impact Insulation Class, Delta Impact Insulation Class, and Sound Transmission Class

Urban Surfaces Foundations Luxury Vinyl Plank Flooring
6-inch Concrete Slab

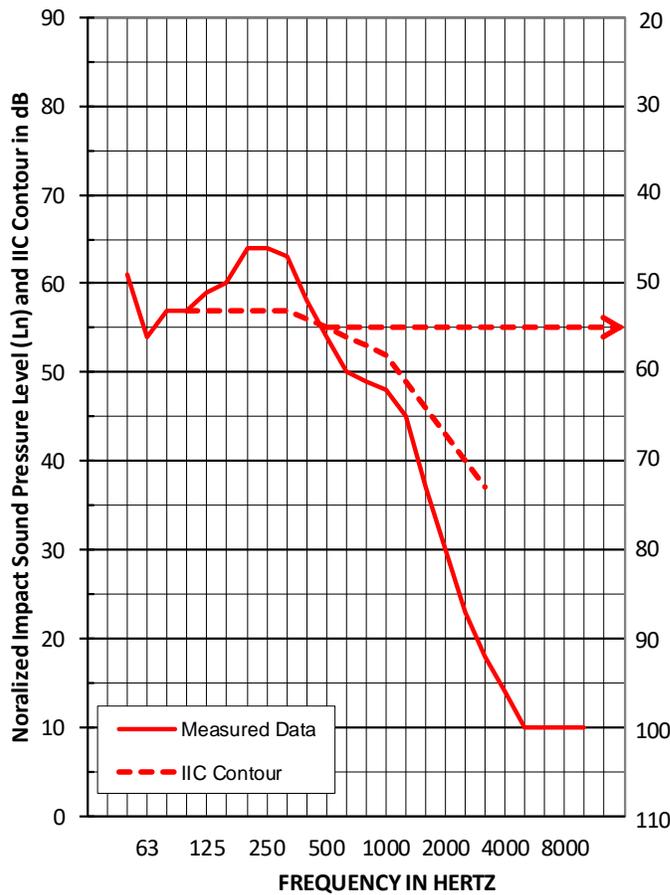
Impact Insulation Class Test FC23-0755: IIC 55

Finish Flooring	4.5 mm Urban Surfaces Foundations Luxury Vinyl Plank
Assembly Type	152.4 mm Concrete
Ceiling	No ceiling

Test Date:	May 7, 2023	
Construction Date:	May 7, 2023	
Test Specimen Area:	11	sq.m.
Receiving Room Volume:	159	cu.m.
Receiving Room Temperature:	17.7-17.7	degrees C
Receiving Room Relative Humidity:	67-67	percent

95% Confidence		
Freq	Limit	Ln
50	1.8	61
63	3.9	54
80	2.7	57
100	0.7	57
125	1.1	59
160	0.7	60
200	0.9	64
250	0.7	64
315	0.6	63
400	0.4	58
500	0.4	54
630	0.6	50
800	0.7	49
1000	0.3	48
1250	0.4	45
1600	0.4	37
2000	0.5	30
2500	0.7	23
3150	0.9	18
4000	1.1	<u>14</u>
5000	0.7	<u>10</u>
6300	0.5	<u>10</u>
8000	0.3	<u>10</u>
10000	0.3	<u>10</u>

All tests were conducted in accordance with ASTM E492, "Standard Test Method for Laboratory Measurement of Impact Sound Transmission through Floor-Ceiling Assemblies Using the Tapping Machine." The IIC is a single-number rating derived from the Impact Sound Pressure Level in accordance with ASTM E989, "Standard Classification for Determination of Impact Insulation Class (IIC)." Results are presented above.

95% confidence intervals represent uncertainty for microphone averaging, not tapping positions.

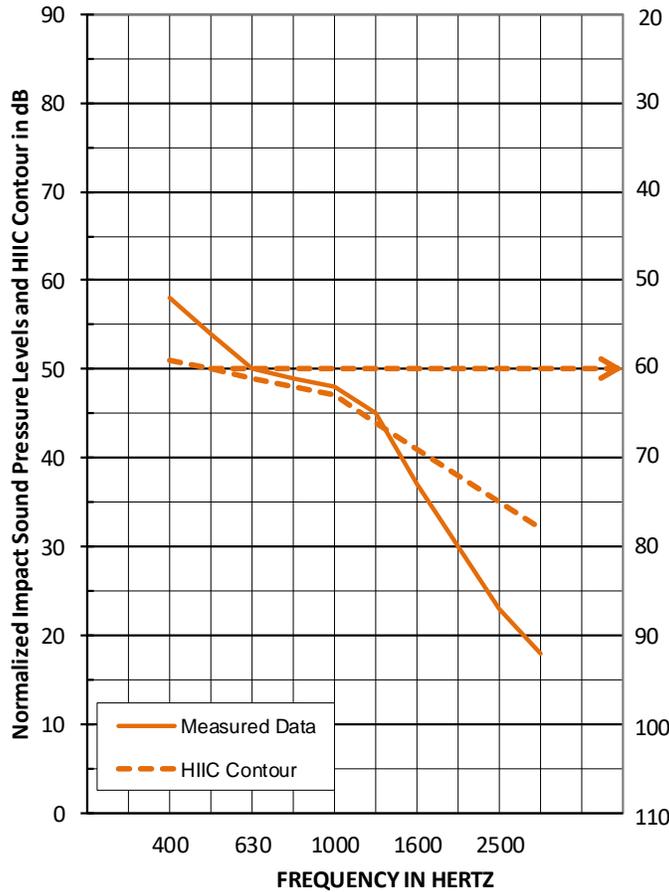
High-frequency Impact Insulation Class Test FC23-0755: HIIC 60

Finish Flooring	4.5 mm Urban Surfaces Foundations Luxury Vinyl Plank
Assembly Type	152.4 mm Concrete
Ceiling	No ceiling

Test Date:	May 7, 2023	
Construction Date:	May 7, 2023	
Test Specimen Area:	11	sq.m.
Receiving Room Volume:	159	cu.m.
Receiving Room Temperature:	17.7-17.7	degrees C
Receiving Room Relative Humidity:	67-67	percent

95% Confidence		
Freq	Limit	Ln
400	0.4	58
500	0.4	54
630	0.6	50
800	0.7	49
1000	0.3	48
1250	0.4	45
1600	0.4	37
2000	0.5	30
2500	0.7	23
3150	0.9	18

No Ln values were affected by background noise or flanking.

1.2 High-frequency Impact Insulation Class Tests

The HIIC is the High-frequency Impact Insulation Class and is meant to assess the high-frequency impact noise on a floor-ceiling assembly. The higher the value, the better the floor, meaning less noise from high-frequency impacts in the space below.

All tests were conducted in accordance with the requirements of ASTM E492, "Standard Test Method for Laboratory Measurement of Impact Sound Transmission through Floor-Ceiling Assemblies Using the Tapping Machine," using ASTM E3222 "Standard Classification for Determination of High-frequency Impact Sound Ratings" to calculate the High-frequency Impact Insulation Class (HIIC). Results are presented above.

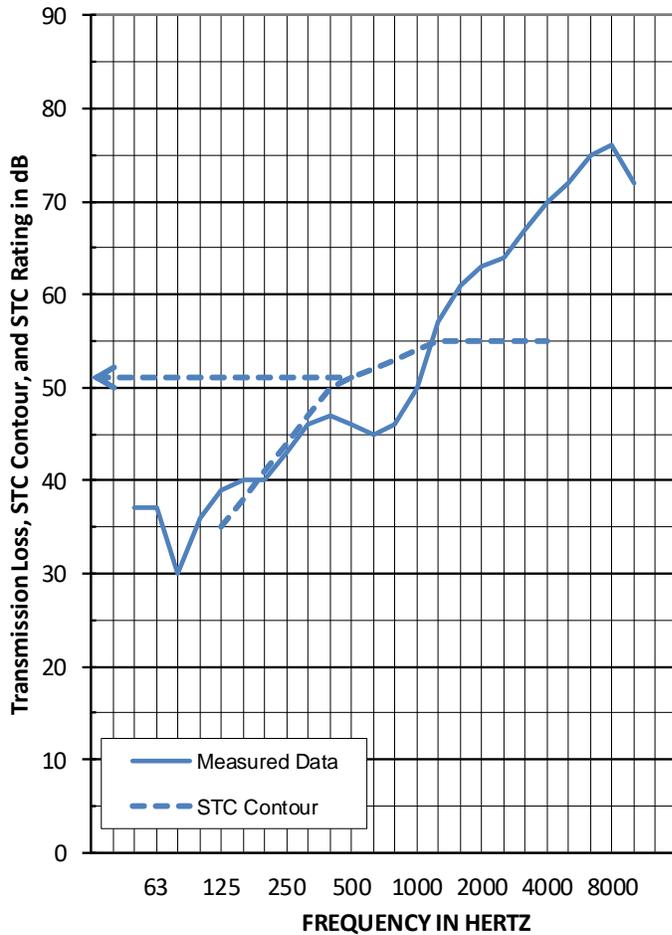
Sound Transmission Class Test FC23-0755: STC 51

Finish Flooring	4.5 mm Urban Surfaces Foundations Luxury Vinyl Plank
Assembly Type	152.4 mm Concrete
Ceiling	No ceiling

Test Date:	May 7, 2023	
Construction Date:	May 7, 2023	
Test Specimen Area:	11	sq.m.
Source/Receiving Room Volume:	190/159	cu.m.
Source/Receiving Room Temperature:	17.7/19.1	degrees C
Source/Receiving Room Relative Humidity:	67/67	percent

Freq	TL
50	37
63	37
80	30
100	36
125	39
160	40
200	40
250	43
315	46
400	47
500	46
630	45
800	46
1000	50
1250	57
1600	61
2000	63
2500	64
3150	67
4000	70
5000	72
6300	<u>75</u>
8000	<u>76</u>
10000	<u>72</u>

1.6 Transmission Loss Tests

All tests were conducted in accordance with ASTM E90, “Standard Test Method for Laboratory Measurement of Airborne Sound Transmission Loss of Building Partitions,” using the single-direction method. STC is a single-number rating derived from measured values of Sound Transmission Loss through a test specimen in accordance with ASTM E413, “Classification for Rating Sound Insulation.” Results are presented above.

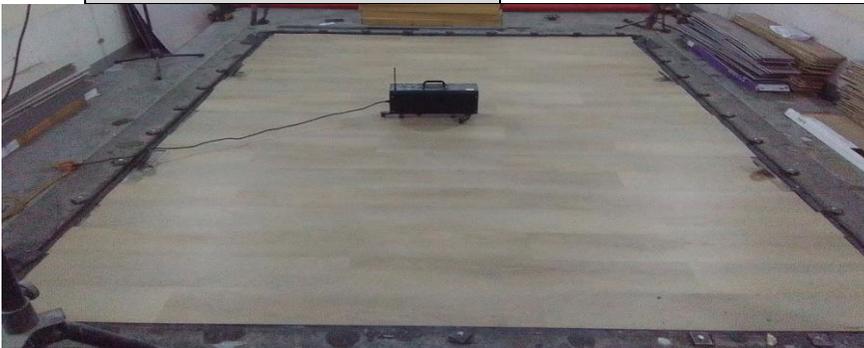
Photo 1: View of Source Chamber, finish flooring installation observed

- Finish flooring: Loose laid. The flooring had an attached foam pad backing.
- Concrete slab: Installed in a test frame flush to the source room. Mats of #5 reinforcing bars were placed 25.4 mm from both the top and bottom of the slab, with bars spaced on 305 mm centers in both directions. The test frame was isolated from the structure with a dense neoprene gasket. This slab was an existing assembly, reused. No noticeable shrinkage or cracking was visible.

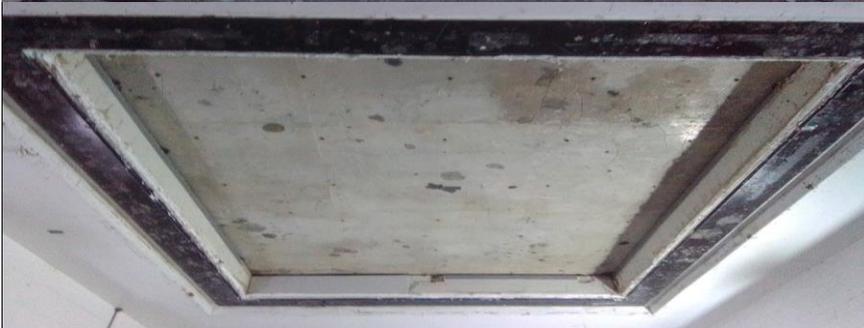
Photo 2: View of Receive Chamber, bottom of concrete slab observed
