# Laboratory Acoustical Test Report

*FC23-0759*

Impact Insulation Class and Sound Transmission Class

## **Test Assembly:**

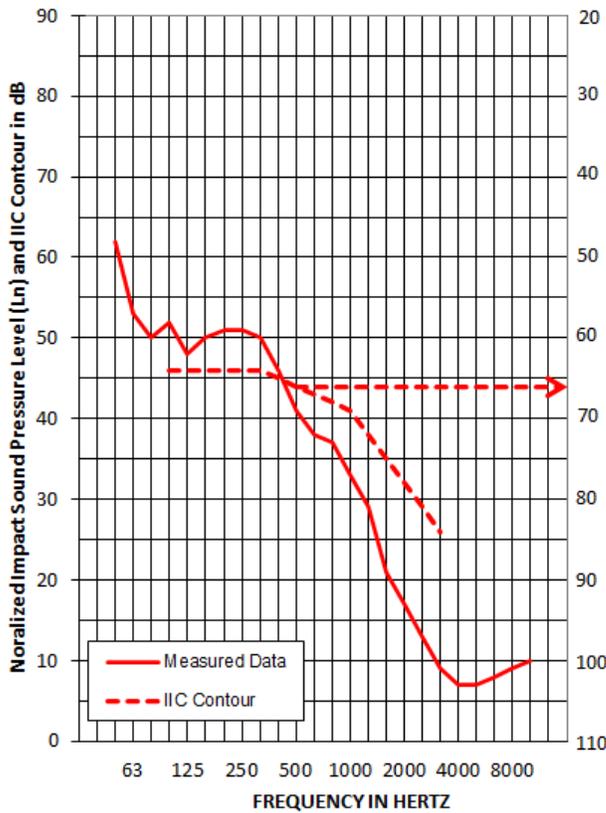
### Impact Insulation Class Test FC23-0759: IIC 66

Finish Flooring	4.5 mm Urban Surfaces Foundations Luxury Vinyl Plank
Concrete Slab	152.4 mm 5000 PSI Concrete Slab
Drywall Main Beam	43 mm Armstrong HD8906 Drywall Main Beam
Cross Tee	37.3 mm Armstrong XL8945P Cross Tee
Fiberglass Insulation	88.9 mm Johns Manville Unfaced R-13 Fiberglass Insulation
Gypsum Panel	15.9 mm National Gypsum Gold Bond Fire-Shield® Type X Gypsum Panel

Test Date:	May 8, 2023	
Construction Date:	May 8, 2023	
Test Specimen Area:	11	sq.m.
Receiving Room Volume:	156	cu.m.
Receiving Room Temperature:	17.3-17.3	degrees C
Receiving Room Relative Humidity:	71-71	percent

95% Confidence		
Freq	Limit	Ln
50	2.8	62
63	2.2	53
80	2.1	50
100	1.2	52
125	0.9	48
160	0.8	50
200	0.5	51
250	0.5	51
315	0.8	50
400	0.7	46
500	0.4	41
630	0.5	38
800	0.5	37
1000	0.4	33
1250	0.4	29
1600	0.3	<u>21</u>
2000	0.2	<u>17</u>
2500	0.5	<u>13</u>
3150	0.5	<u>9</u>
4000	0.3	<u>7</u>
5000	0.3	<u>7</u>
6300	0.2	<u>8</u>
8000	0.2	<u>9</u>
10000	0.3	<u>10</u>

All tests were conducted in accordance with ASTM E492, "Standard Test Method for Laboratory Measurement of Impact Sound Transmission through Floor-Ceiling Assemblies Using the Tapping Machine." The IIC is a single-number rating derived from the Impact Sound Pressure Level in accordance with ASTM E989, "Standard Classification for Determination of Impact Insulation Class (IIC)." Results are presented above.

95% confidence intervals represent uncertainty for microphone averaging, not tapping positions.

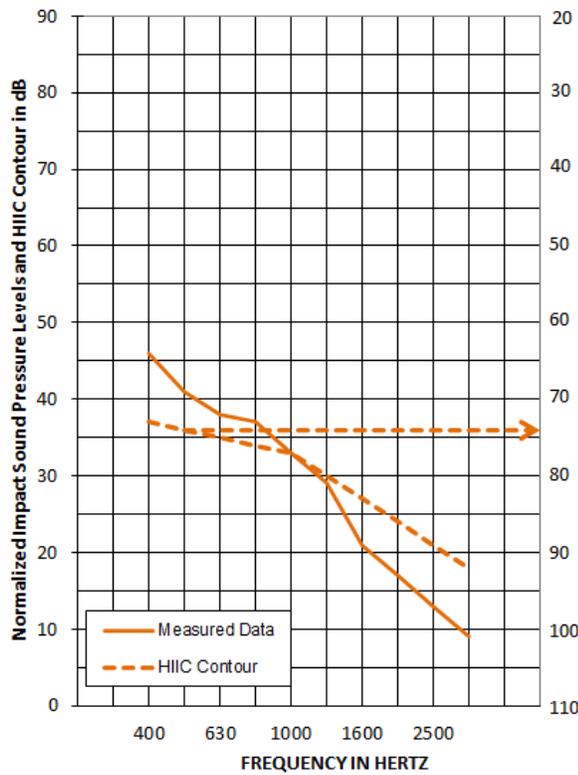
### High-frequency Impact Insulation Class Test FC23-0759: HIIC 74

Finish Flooring	4.5 mm Urban Surfaces Foundations Luxury Vinyl Plank
Concrete Slab	152.4 mm 5000 PSI Concrete Slab
Drywall Main Beam	43 mm Armstrong HD8906 Drywall Main Beam
Cross Tee	37.3 mm Armstrong XL8945P Cross Tee
Fiberglass Insulation	88.9 mm Johns Manville Unfaced R-13 Fiberglass Insulation
Gypsum Panel	15.9 mm National Gypsum Gold Bond Fire-Shield® Type X Gypsum Panel

Test Date:	May 8, 2023	
Construction Date:	May 8, 2023	
Test Specimen Area:	11	sq.m.
Receiving Room Volume:	156	cu.m.
Receiving Room Temperature:	17.3-17.3	degrees C
Receiving Room Relative Humidity:	71-71	percent

95% Confidence		
Freq	Limit	Ln
400	0.7	46
500	0.4	41
630	0.5	38
800	0.5	37
1000	0.4	33
1250	0.4	29
1600	0.3	<u>21</u>
2000	0.2	<u>17</u>
2500	0.5	<u>13</u>
3150	0.5	<u>9</u>

The HIIC is the High-frequency Impact Insulation Class and is meant to assess the high-frequency impact noise on a floor-ceiling assembly. The higher the value, the better the floor, meaning less noise from high-frequency impacts in the space below.

All tests were conducted in accordance with the requirements of ASTM E492, "Standard Test Method for Laboratory Measurement of Impact Sound Transmission through Floor-Ceiling Assemblies Using the Tapping Machine," using ASTM E3222 "Standard Classification for Determination of High-frequency Impact Sound Ratings" to calculate the High-frequency Impact Insulation Class (HIIC). Results are presented above.

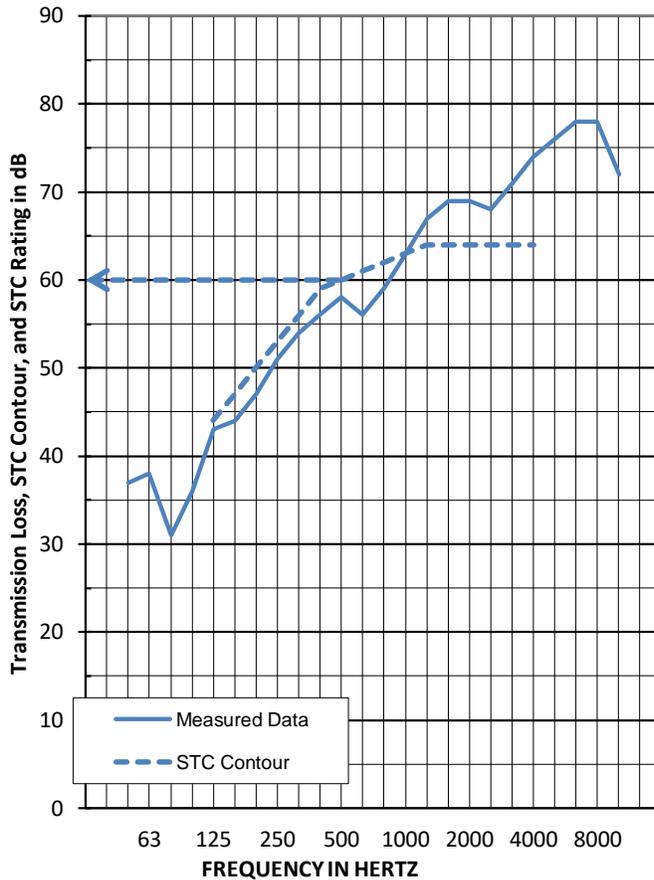
### Sound Transmission Class Test FC23-0759: STC 60

Finish Flooring	4.5 mm Urban Surfaces Foundations Luxury Vinyl Plank
Concrete Slab	152.4 mm 5000 PSI Concrete Slab
Drywall Main Beam	43 mm Armstrong HD8906 Drywall Main Beam
Cross Tee	37.3 mm Armstrong XL8945P Cross Tee
Fiberglass Insulation	88.9 mm Johns Manville Unfaced R-13 Fiberglass Insulation
Gypsum Panel	15.9 mm National Gypsum Gold Bond Fire-Shield® Type X Gypsum Panel

Test Date: May 8, 2023  
 Construction Date: May 8, 2023  
 Test Specimen Area: 11 sq.m.  
 Source/Receiving Room Volume: 190/156 cu.m.  
 Source/Receiving Room Temperature: 18.7/19.4 degrees C  
 Source/Receiving Room Relative Humidity: 67/67 percent

Freq	TL
50	37
63	38
80	31
100	36
125	43
160	44
200	47
250	51
315	54
400	56
500	58
630	56
800	59
1000	63
1250	67
1600	69
2000	69
2500	68
3150	71
4000	74
5000	76
6300	78
8000	78
10000	72

All tests were conducted in accordance with ASTM E90, "Standard Test Method for Laboratory Measurement of Airborne Sound Transmission Loss of Building Partitions," using the single-direction method. STC is a single-number rating derived from measured values of Sound Transmission Loss through a test specimen in accordance with ASTM E413, "Classification for Rating Sound Insulation." Results are presented above.

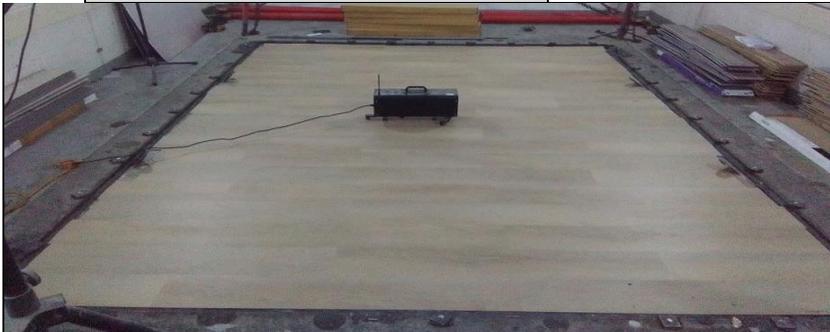
*Photo 1: View of Source Chamber, finish flooring installation observed*

- Finish flooring: Loose laid. The flooring had an attached foam pad backing.
- Concrete slab: Installed in a test frame flush to the source room. Mats of #5 reinforcing bars were placed 25.4 mm from both the top and bottom of the slab, with bars spaced on 305 mm centers in both directions. The test frame was isolated from the structure with a dense neoprene gasket. This slab was an existing assembly, reused. No noticeable shrinkage or cracking was visible.

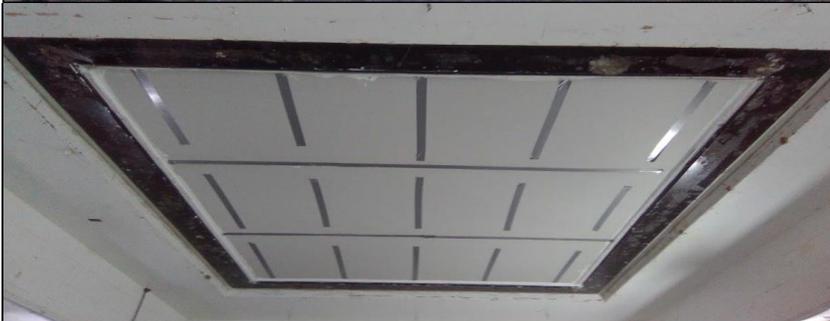
*Photo 2: View of Receive Chamber, bottom of concrete slab observed*

- Drywall Main Beam: Twelve-gauge hanger wires were attached to the bottom side of the concrete at twelve locations and then to the main beams. The hanger wire was twisted around itself a minimum of three times within 76 mm creating a 305 mm plenum. The measured steel thickness was 0.5 mm.
