Laboratory Acoustical Test Report

FC23-0888

Impact Insulation Class and Sound Transmission Class

Urban Surfaces 7501 Canal Street

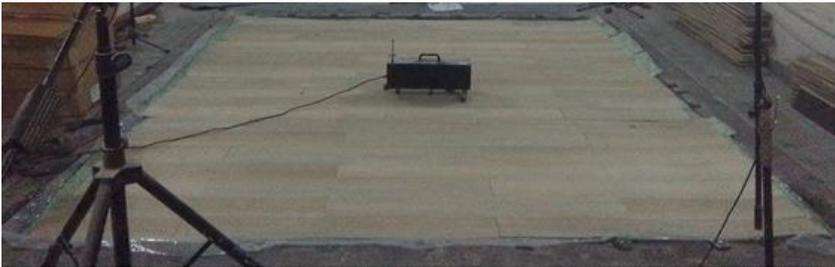
Photo 1: View of Source Chamber, finish flooring installation observed

- Finish flooring: Adhered to underlayment with manufacturer's adhesive using a 0.79 mm by 1.59 mm by 0.79 mm trowel. Adhesive allowed to cure per manufacturer's specifications.

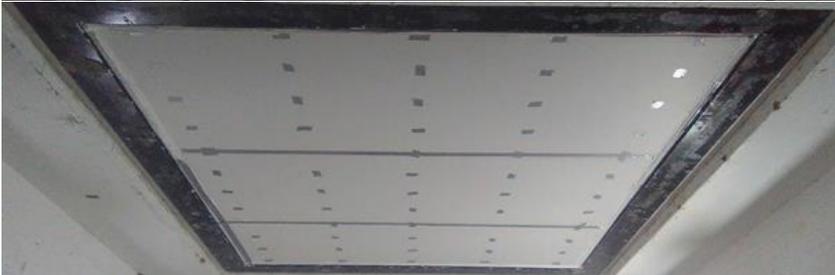
Photo 2: View of Receive Chamber, bottom of gypsum panel observed

- Cross Tee: Inserted into the main beams on 610 mm centers. The measured steel thickness was 0.5 mm.
- Gypsum Panel: Fastened with 25.4 mm fine thread drywall screws on 305 mm centers. Seams and perimeter sealed with Pecora AC-20® Acoustical Sealant and covered with pressure-sensitive tape.
