Laboratory Acoustical Test Report

FC23-0882

Impact Insulation Class and Sound Transmission Class

Urban Surfaces 7501 Canal Street

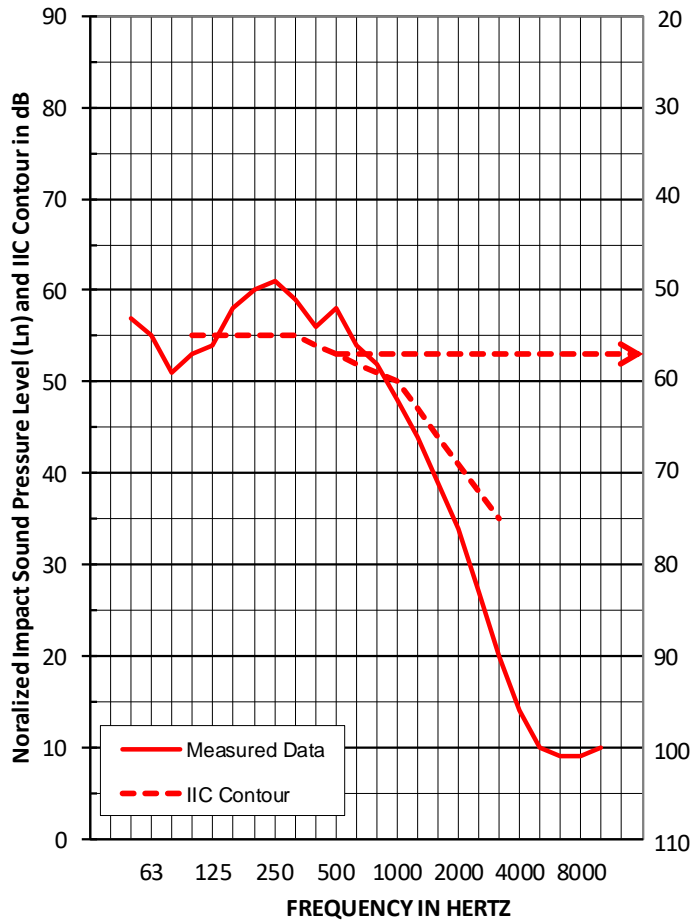
Impact Insulation Class Test FC23-0882: IIC 57

Finish Flooring
Sound Mat
Assembly Type
Ceiling

3 mm Urban Surfaces 7501 Canal Street (Adhered to Sound Mat)
1.3 mm Urban Surfaces FloorSilencer Pro (Adhered to Assembly)
203 mm 5000 PSI Concrete Slab
No ceiling

Test Date: October 10, 2023
Construction Date: October 10, 2023
Test Specimen Area: 11 sq.m.
Receiving Room Volume: 158 cu.m.
Receiving Room Temperature: 17.9-18.3 degrees C
Receiving Room Relative Humidity: 58-59 percent

95% Confidence		
Freq	Limit	Ln
50	2.1	<u>57</u>
63	5.1	55
80	2.5	51
100	1.0	53
125	1.1	54
160	1.2	58
200	0.6	60
250	1.1	61
315	0.9	59
400	0.4	56
500	0.4	58
630	0.6	54
800	0.8	52
1000	0.6	48
1250	0.5	44
1600	0.6	39
2000	0.6	34
2500	0.9	27
3150	0.9	20
4000	1.0	<u>14</u>
5000	0.7	<u>10</u>
6300	0.3	<u>9</u>
8000	0.2	<u>9</u>
10000	0.5	<u>10</u>

Background Affected

All tests were conducted in accordance with ASTM E492, "Standard Test Method for Laboratory Measurement of Impact Sound Transmission through Floor-Ceiling Assemblies Using the Tapping Machine." The IIC is a single-number rating derived from the Impact Sound Pressure Level in accordance with ASTM E989, "Standard Classification for Determination of Impact Insulation Class (IIC)." Results are presented above.

95% confidence intervals represent uncertainty for microphone averaging, not tapping positions.

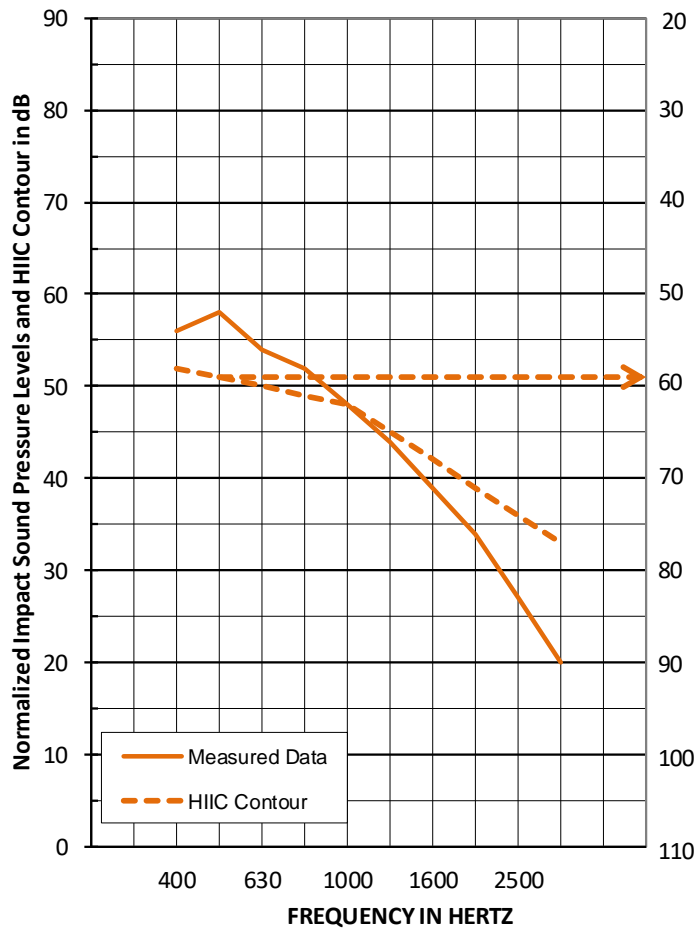
High-frequency Impact Insulation Class Test FC23-0882: HIIC 59

Finish Flooring	3 mm Urban Surfaces 7501 Canal Street (Adhered to Sound Mat)
Sound Mat	1.3 mm Urban Surfaces FloorSilencer Pro (Adhered to Assembly)
Assembly Type	203 mm 5000 PSI Concrete Slab
Ceiling	No ceiling

Test Date:	October 10, 2023	
Construction Date:	October 10, 2023	
Test Specimen Area:	11	sq.m.
Receiving Room Volume:	158	cu.m.
Receiving Room Temperature:	17.9-18.3	degrees C
Receiving Room Relative Humidity:	58-59	percent

95% Confidence		
Freq	Limit	Ln
400	0.4	56
500	0.4	58
630	0.6	54
800	0.8	52
1000	0.6	48
1250	0.5	44
1600	0.6	39
2000	0.6	34
2500	0.9	27
3150	0.9	20

No Ln values were affected by background noise or flanking.

The HIIC is the High-frequency Impact Insulation Class and is meant to assess the high-frequency impact noise on a floor-ceiling assembly. The higher the value, the better the floor, meaning less noise from high-frequency impacts in the space below.

All tests were conducted in accordance with the requirements of ASTM E492, "Standard Test Method for Laboratory Measurement of Impact Sound Transmission through Floor-Ceiling Assemblies Using the Tapping Machine," using ASTM E3222 "Standard Classification for Determination of High-frequency Impact Sound Ratings" to calculate the High-frequency Impact Insulation Class (HIIC). Results are presented above.

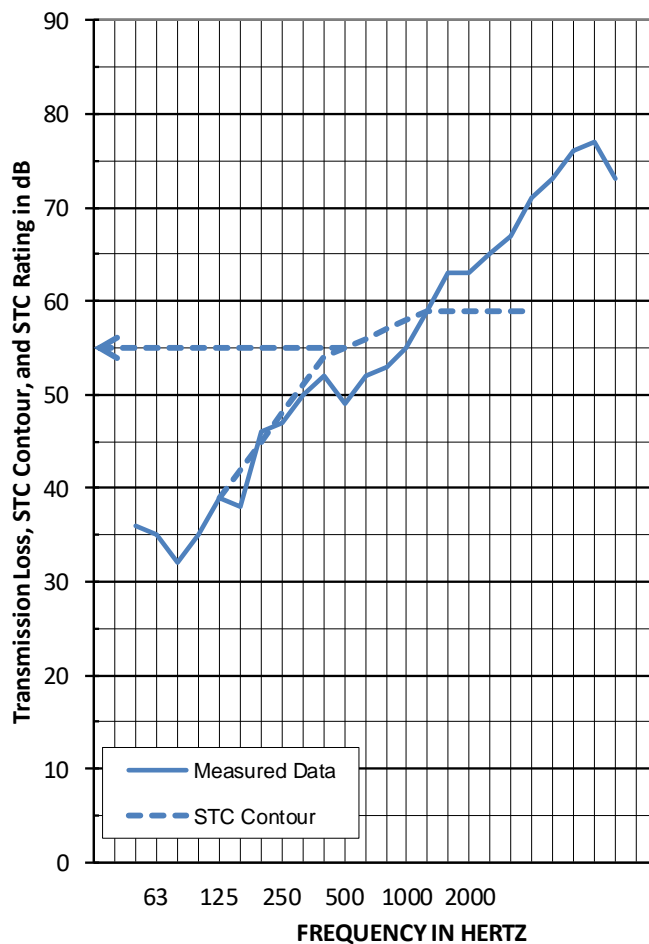
Sound Transmission Class Test FC23-0882: STC 55

Finish Flooring	3 mm Urban Surfaces 7501 Canal Street (Adhered to Sound Mat)
Sound Mat	1.3 mm Urban Surfaces FloorSilencer Pro (Adhered to Assembly)
Assembly Type	203 mm 5000 PSI Concrete Slab
Ceiling	No ceiling

Test Date:	October 10, 2023
Construction Date:	October 10, 2023
Test Specimen Area:	11 sq.m.
Source/Receiving Room Volume:	190/158 cu.m.
Source/Receiving Room Temperature:	18.1/20.5 degrees C
Source/Receiving Room Relative Humidity:	59/59 percent

Freq	TL
50	36
63	35
80	32
100	35
125	39
160	38
200	46
250	47
315	50
400	52
500	49
630	52
800	53
1000	55
1250	59
1600	63
2000	63
2500	65
3150	67
4000	71
5000	73
6300	76
8000	77
10000	73

Background Affected

Flanking Affected

Background and Flanking Affected

All tests were conducted in accordance with ASTM E90, "Standard Test Method for Laboratory Measurement of Airborne Sound Transmission Loss of Building Partitions," using the single-direction method. STC is a single-number rating derived from measured values of Sound Transmission Loss through a test specimen in accordance with ASTM E413, "Classification for Rating Sound Insulation." Results are presented above.

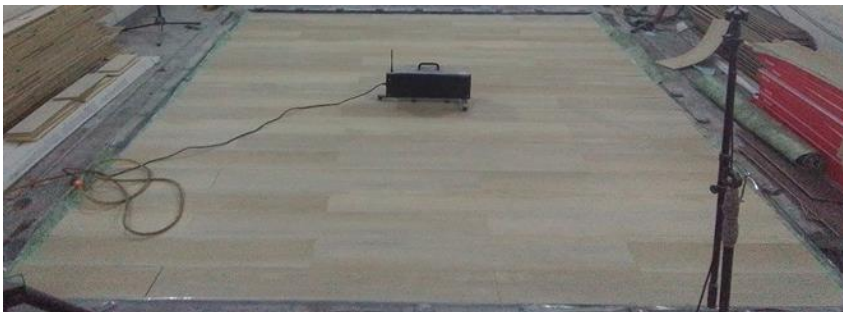
Photo 1: View of Source Chamber, finish flooring installation observed

- Finish flooring: Adhered to underlayment with manufacturer's adhesive using a 0.79 mm by 1.59 mm by 0.79 mm trowel. Adhesive allowed to cure per manufacturer's specifications.

- Flooring underlayment: The underlayment was adhered to 2-mil polyethylene plastic sheeting with the manufacturer's adhesive, which was spread using a 0.79 mm by 1.59 mm by 0.79 mm trowel. Adhesive was allowed to cure per manufacturer's specifications.

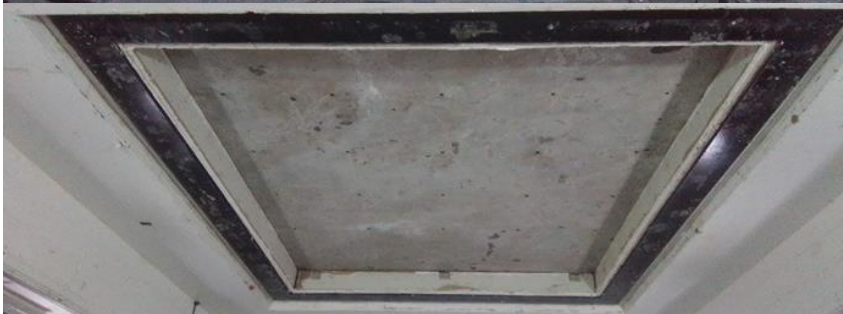
Photo 2: View of Receive Chamber, bottom of concrete slab observed

- Concrete slab: Installed in a test frame flush to the source room. Mats of #5 reinforcing bars were placed 25.4 mm from both the top and bottom of the slab, with bars spaced on 305 mm centers in both directions. The test frame was isolated from the structure with a dense neoprene gasket. This slab was an existing assembly, reused. No noticeable shrinkage or cracking was visible.
