# **Laboratory Acoustical Test Report**

FC22-0547R2

Impact Insulation Class and Sound Transmission Class

## **Test Assembly:**

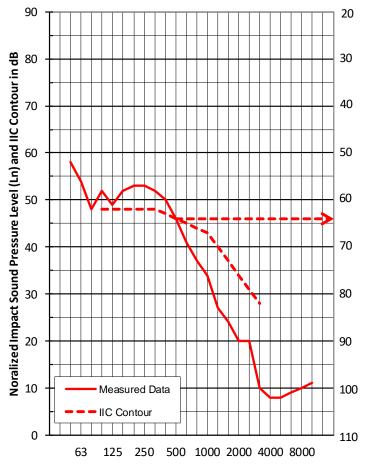
## Impact Insulation Class Test FC22-0547: IIC 64

Finish Flooring Assembly Type Drywall Main Beam Cross Tee Fiberglass Insulation Gypsum Panel 5 mm Urban Surfaces Studio 12/20 SPC Flooring 152.4 mm 5000 PSI Concrete Slab 43 mm Armstrong HD8906 37.3 mm Armstrong XL8945P 88.9 mm Johns Manville Unfaced R-13

15.9 mm National Gypsum Gold Bond® Fire-Shield® Type X

Test Date: September 18, 2022 Construction Date: September 18, 2022

Test Specimen Area: 11 sq.m.
Receiving Room Volume: 156 cu.m.
Receiving RoomTemperature: 22.7-22.7 degrees C
Receiving Room Relative Humidity: 64-65 percent

95%			
Confidence				
Freq	Freq Limit Ln			
50	1.5	58		
63	4.1	54		
80	1.3	48		
100	8.0	52		
125	1.1	49		
160	1.2	52		
200	0.6	53		
250	0.9	53		
315	0.7	52		
400	0.5	50		
500	0.7	46		
630	0.5	41		
800	0.5	37		
1000	0.5	34		
1250	0.4	27		
1600	0.2	24		
2000	0.2	20		
2500	0.5	20		
3150	0.3	<u>10</u>		
4000	0.3	<u>8</u>		
5000	0.4	<u>8</u>		
6300	0.4	<u>9</u>		
8000	0.5	<u>10</u>		
10000	0.5	<u>11</u>		
Daskground Affacted

Background Affected

FREQUENCY IN HERTZ

All tests were conducted in accordance with ASTM E492, "Standard Test Method for Laboratory Measurement of Impact Sound Transmission through Floor-Ceiling Assemblies Using the Tapping Machine." The IIC is a single-number rating derived from the Impact Sound Pressure Level in accordance with ASTM E989, "Standard Classification for Determination of Impact Insulation Class (IIC)." Results are presented above.

95% confidence intervals represent uncertainty for microphone averaging, not tapping positions.

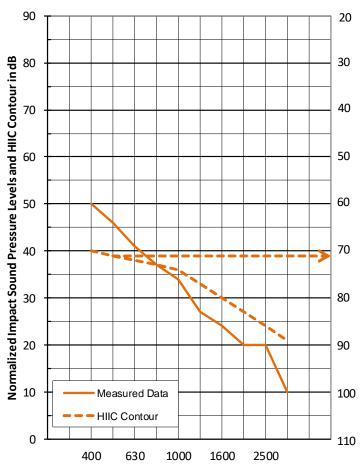
### High-frequency Impact Insulation Class Test FC22-0547: HIIC 71

Finish Flooring Assembly Type Drywall Main Beam Cross Tee Fiberglass Insulation 5 mm Urban Surfaces Studio 12/20 SPC Flooring 152.4 mm 5000 PSI Concrete Slab

152.4 mm 5000 PSI Concrete Sla 43 mm Armstrong HD8906

37.3 mm Armstrong XL8945P

88.9 mm Johns Manville Unfaced R-13

Gypsum Panel 15.9 mm National Gypsum Gold Bond® Fire-Shield® Type X

**FREQUENCY IN HERTZ**

95%				
Confidence					
Freq	Freq Limit				
400	0.5	50			
500	0.7	46			
630	0.5	41			
800	0.5	37			
1000	0.5	34			
1250	0.4	27			
1600	0.2	24			
2000	0.2	20			
2500	0.5	20			
3150	0.3	<u>10</u>

**Background Affected**

The HIIC is the High-frequency Impact Insulation Class and is meant to assess the high-frequency impact noise on a floor-ceiling assembly. The higher the value, the better the floor, meaning less noise from high-frequency impacts in the space below.

All tests were conducted in accordance with the requirements of ASTM E492, "Standard Test Method for Laboratory Measurement of Impact Sound Transmission through Floor-Ceiling Assemblies Using the Tapping Machine," using ASTM E3222 "Standard Classification for Determination of High-frequency Impact Sound Ratings" to calculate the High-frequency Impact Insulation Class (HIIC). Results are presented above.

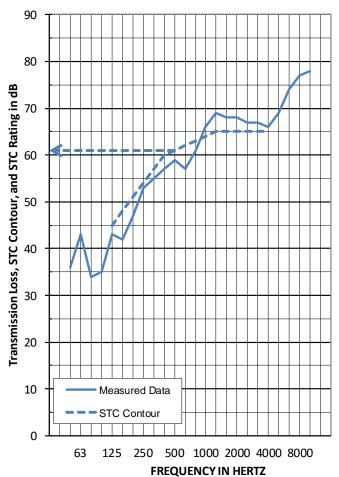
### Sound Transmission Class Test FC22-0547: STC 61

Finish Flooring Assembly Type Drywall Main Beam Cross Tee Fiberglass Insulation Gypsum Panel

5 mm Urban Surfaces Studio 12/20 SPC Flooring 152.4 mm 5000 PSI Concrete Slab 43 mm Armstrong HD8906 37.3 mm Armstrong XL8945P 88.9 mm Johns Manville Unfaced R-13

15.9 mm National Gypsum Gold Bond® Fire-Shield® Type X

Test Date: September 18, 2022 Construction Date: September 18, 2022

Test Specimen Area: 11 sq.m. Source/Receiving Room Volume: 190/156 cu.m. Source/Receiving Room Temperature: 22.7/21 degrees C 64/64 Source/Receiving Room Relative Humidity: percent

Freq	TL
50	36
63	43
80	34
100	35
125	43
160	42
200	47
250	53
315	55
400	57
500	59
630	57
800	61
1000	66
1250	69
1600	68
2000	68
2500	67
3150	67
4000	66
5000	69
6300	<u>74</u>
8000	<u>77</u>
10000	<u>78</u>

Background Affected Flanking Affected

**Background and Flanking Affected**

All tests were conducted in accordance with ASTM E90, "Standard Test Method for Laboratory Measurement of Airborne Sound Transmission Loss of Building Partitions," using the single-direction method. STC is a single-number rating derived from measured values of Sound Transmission Loss through a test specimen in accordance with ASTM E413, "Classification for Rating Sound Insulation." Results are presented above.

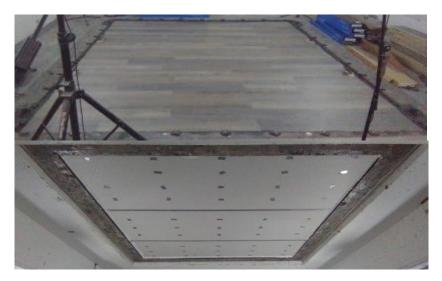
Photo 1: View of Source Chamber, finish flooring installation observed

Photo 2: View of Receive Chamber, bottom of ceiling observed

- Urban Surfaces Studio 12/20 SPC Flooring: Loose laid
- Concrete Slab: Installed in a test frame flush to the source room. Mats of #5 reinforcing bars were placed 25.4 mm from both the top and bottom of the slab, with bars spaced on 305 mm centers in both directions. No noticeable shrinkage or cracking was visible on the specimen.

- Drywall Main Beam: Twelve gauge hanger wires were attached to the bottom side of the concrete at twelve locations and then to the main beams. The hanger wire was twisted around itself a minimum of three times within 76 mm creating a 305 mm plenum. The measured steel thickness was 0.5 mm.

- Cross Tee: Inserted into the main beams on 610 mm centers. The measured steel thickness was 0.5 mm
- Fiberglass Insulation: Loose laid onto the ceiling grid system

- Gypsum Panel: Fastened with 25.4 mm (1") fine thread drywall screws on 305 mm centers. Seams and perimeter sealed with Pecora AC-20® Acoustical Sealant and covered with pressure-sensitive tape.
