# Laboratory Acoustical Test Report

*FC22-0555*

Impact Insulation Class and Sound Transmission Class

Urban Surfaces Studio 12 SPC Flooring  
5000 PSI Concrete Slab

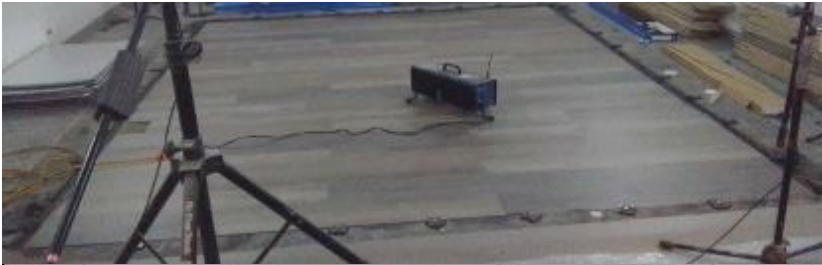
*Photo 1: View of Source Chamber, finish flooring installation observed*

- Urban Surfaces Studio 12 SPC Flooring: Loose laid
- Concrete Slab: Installed in a test frame flush to the source room. Mats of #5 reinforcing bars were placed 25.4 mm from both the top and bottom of the slab, with bars spaced on 305 mm centers in both directions. No noticeable shrinkage or cracking was visible on the specimen.

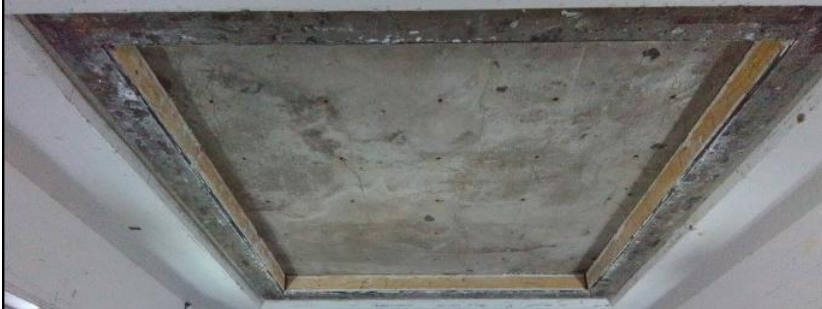
*Photo 2: View of Receive Chamber, bottom of ceiling observed*
